CASE STUDY - BLAST CLEANING & PAINTING

NATIONAL GRID - ABOVE GROUND STATION, KIRRIMUIR

Customer: National Grid **Location:** Above Ground Station Kirrimuir

CASE STUDY - MECHANICAL PREPARATION & PAINTING

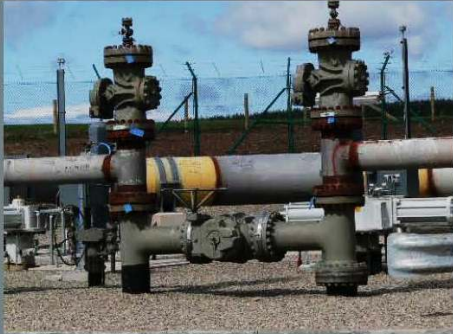
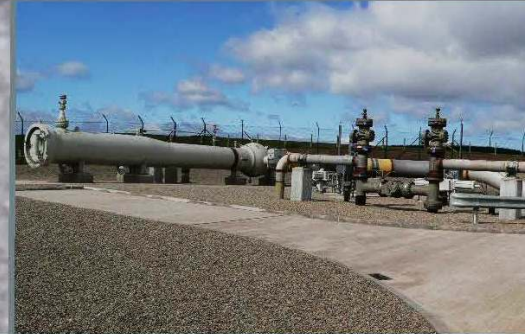
Photos 1 & 3: unpainted gas pipes before works commenced. **Photo 2:** close up of blasted steel to s.a.2.5 profile 50-60 microns.

All pipework was shotblasted to S.A.2.5 to remove all paint and corrosion to leave a blast profile of 50- 60 microns. Once the surface was cleaned a 4 coat isosynate free paint system was applied to leave a Dry Film thickness of 400- 500 microns. All overcoating times and film thickness were strictly adhered to and was inspected by our own Institute of Corrosion registered paint inspector who measured and metered wet and dry film thicknesses as works progressed. The works were completed to a very high standard and will achieve a 20 year barrier against corrosion.

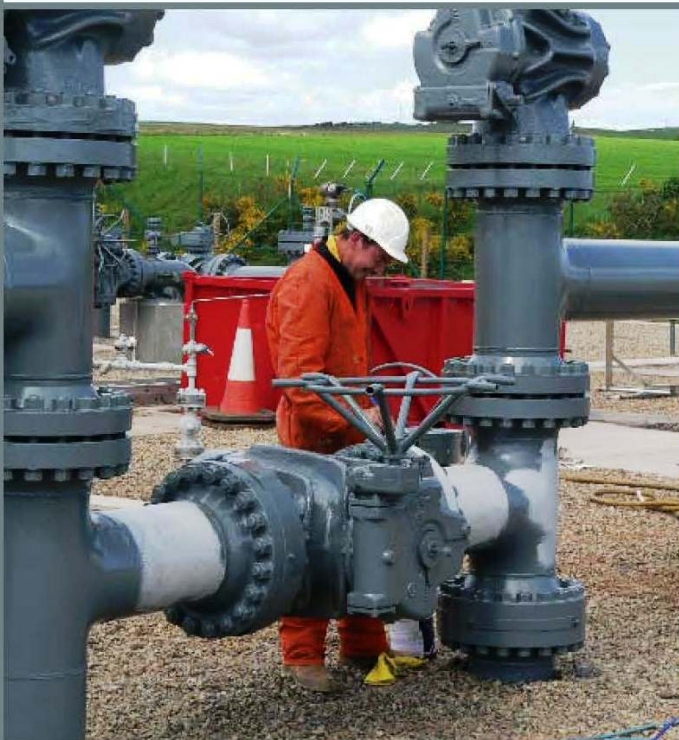
Photo 4: final quality checks.

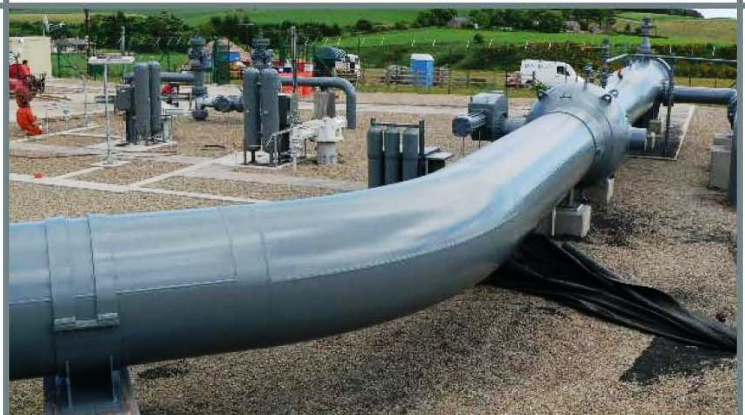
Photo 5: works completed to a very high standard and excellent finish.

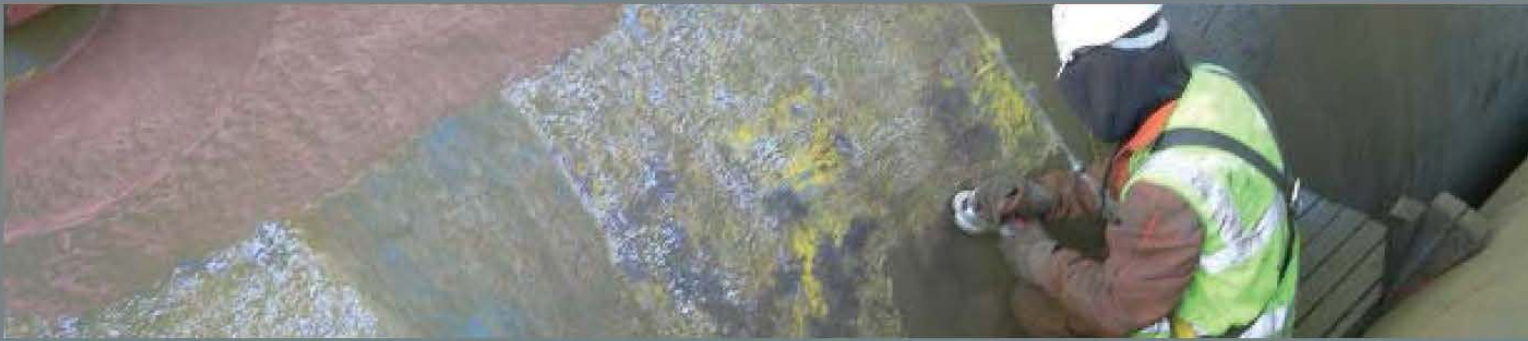
Photo 1: Mechanical preparation of corroded steel surfaces with disc sanding equipment.

Storage tanks showed visible signs of corrosion and coating breakdown on outer surfaces. They were high pressure power washed and mechanically prepared to S.T.2 by descaling any heavy corrosion and completely disc sanding to remove any rust and loose adhering paint.

Once prepared the tanks were dusted down and coated with a 2 pack epoxy high volume solids primer at the end of each day. Once the tanks were completely prepared and primed, a further 3 coats of 2 pack epoxy paint was applied to achieve a further 10 yrs against corrosion.

The mechanically prepared surfaces were primed as the works progressed to provide a barrier against corrosion before cleaning down and applying the final coats.

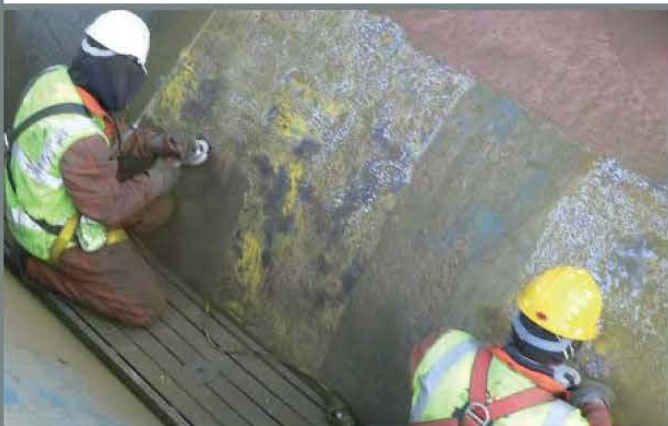
Photo 2: Corroded Steel prior to mechanical preparation.

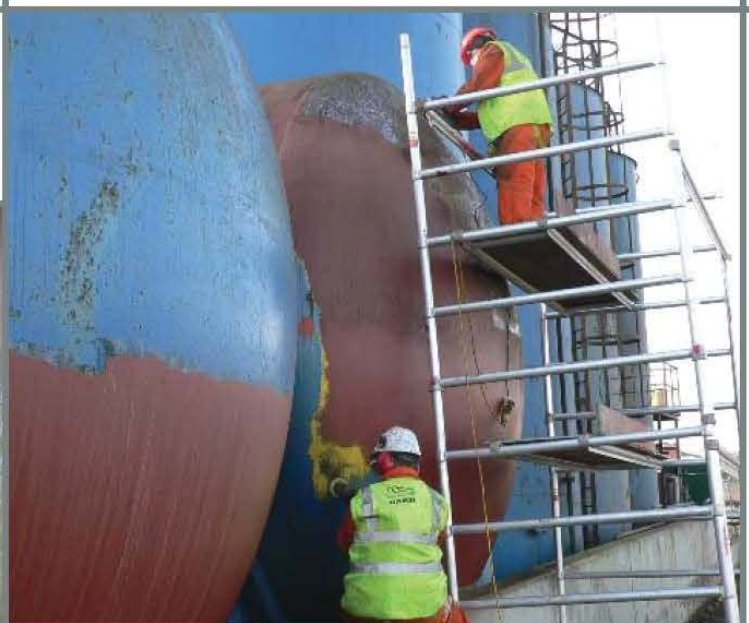
Photo 3: Priming the prepared surfaces.
